# ***WATER QUALITY AND USE***

## **Beneficial Use Attainment**

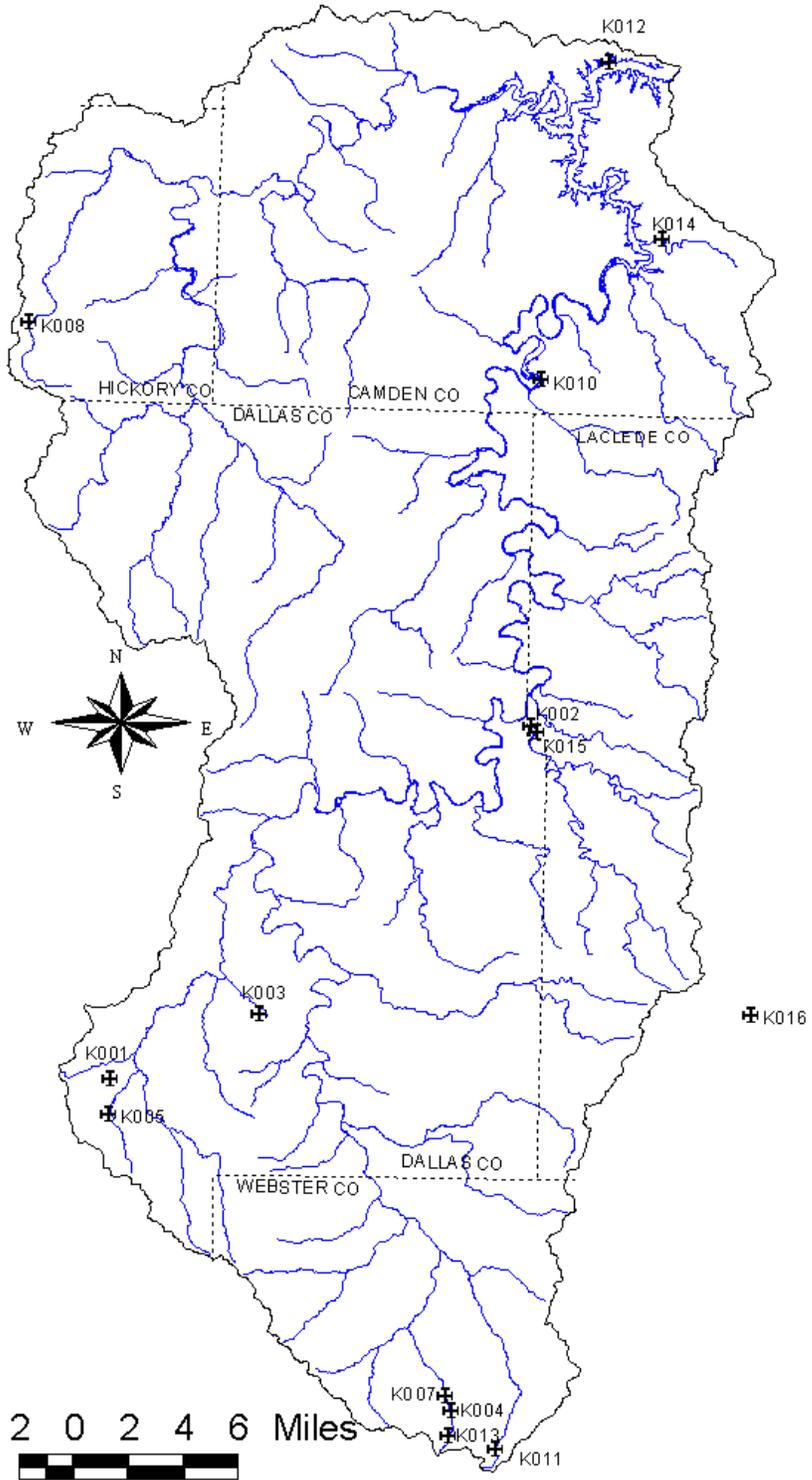
**Figure 13. Documented fish kills and water pollution events within the Niangua River Watershed and spring recharge area.**

Documented fish kills and water pollution events are listed in Table 16 and mapped in Figure 13. MDC records indicate five fish kills have occurred in the watershed since 1979 (Table 16). One chronic fish-kill area is located downstream from the Marshfield sewage treatment facility. Fish mortalities in this area have been attributed to low dissolved oxygen, due to a combination of high nutrient inflow, low stream flows, and high water temperatures (MDNR, unpublished). Marshfield's recent efforts to upgrade their facility are discussed in the Point Source Pollution section. Petroleum product spills from ruptured pipelines have occurred at several sites and been responsible for at least one fish kill. One fish kill was documented at Lake Niangua in 1988. This event was attributed to rapid drawdown of surface water in August that stranded fish in shallow areas with high temperatures and low dissolved oxygen levels. To prevent similar events, the recently approved relicensing agreement limits fluctuations in lake levels to 0.5 feet and requires notification of MDC personnel.

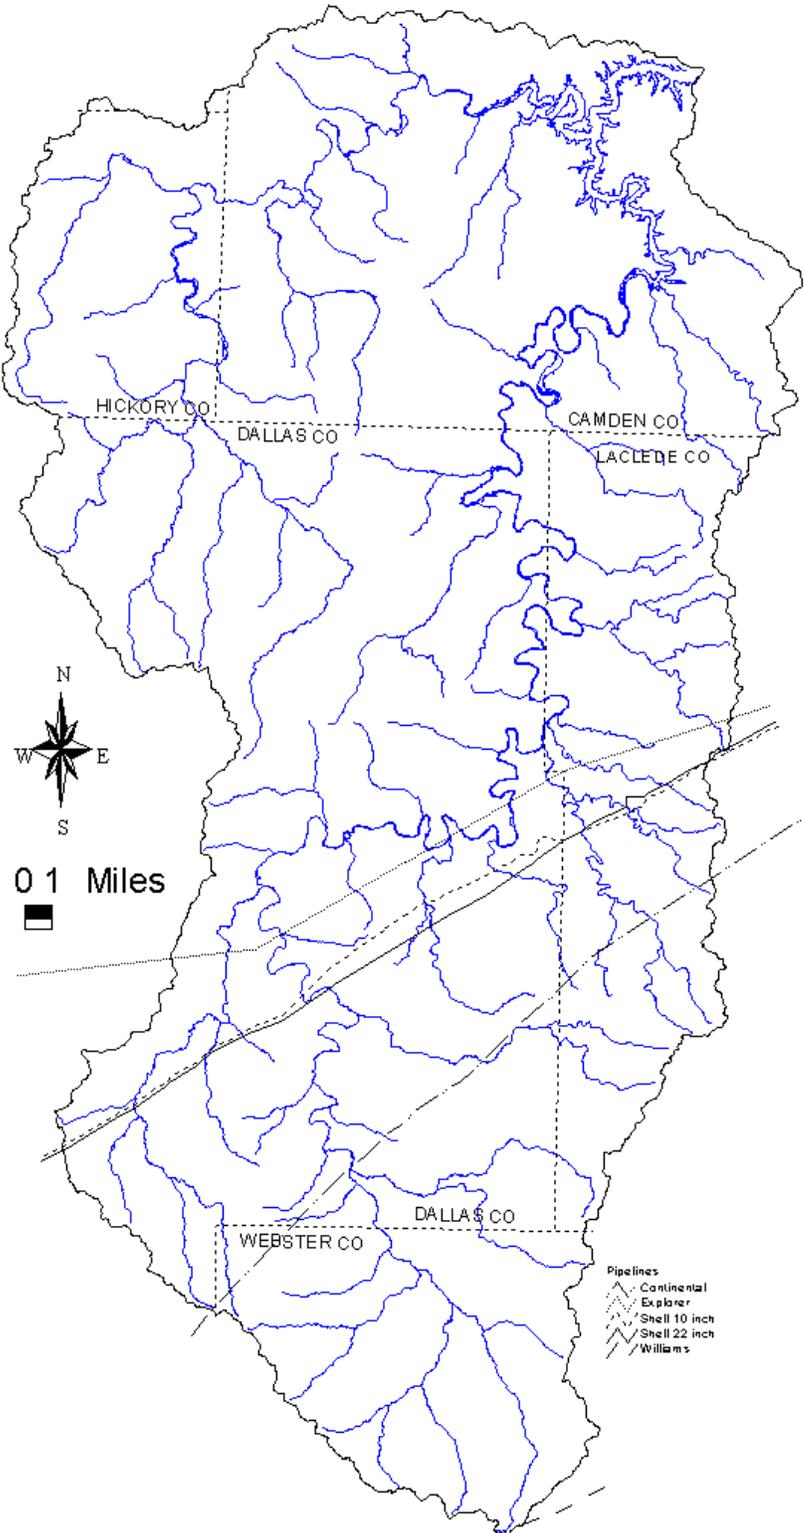
**Figure 14. Buried intrastate pipelines that cross the Niangua Watershed.**

Five buried pipelines cross the Niangua Watershed (Figure 14). Pipelines pose a threat to groundwater as well as streams in the watershed, because they pass through several karst areas with sinkholes and losing streams inside and outside the watershed (Figure 11). Three of the pipelines are used for transporting crude oil, diesel fuel, and fertilizer. The 10-inch Shell pipeline is currently not in use but may be reactivated in the future. The Williams pipeline was reportedly being considered for use as a fiber optics conduit (Vandike, 1992). At least four pipeline ruptures have resulted in water pollution problems and fish kills since 1979 (Table 17). In addition, pipelines have become exposed by streambed erosion at three sites in the past four years (Dousinbury Creek SM 5.5, Greasy Creek SM 11.5, NR SM 100.2). Recent gravel excavation had occurred near all three of these sites, and the resulting headcuts and destabilized channels may have created the erosion problems. Most of the pipelines in the watershed do not appear on 7.5 minute topographic maps, so it has been difficult to determine whether proposed 404 activities may impact pipelines in the vicinity. The recently enacted general permit (MRKGP-34M) includes conditions that should minimize headcutting and channel destabilization. However, COE

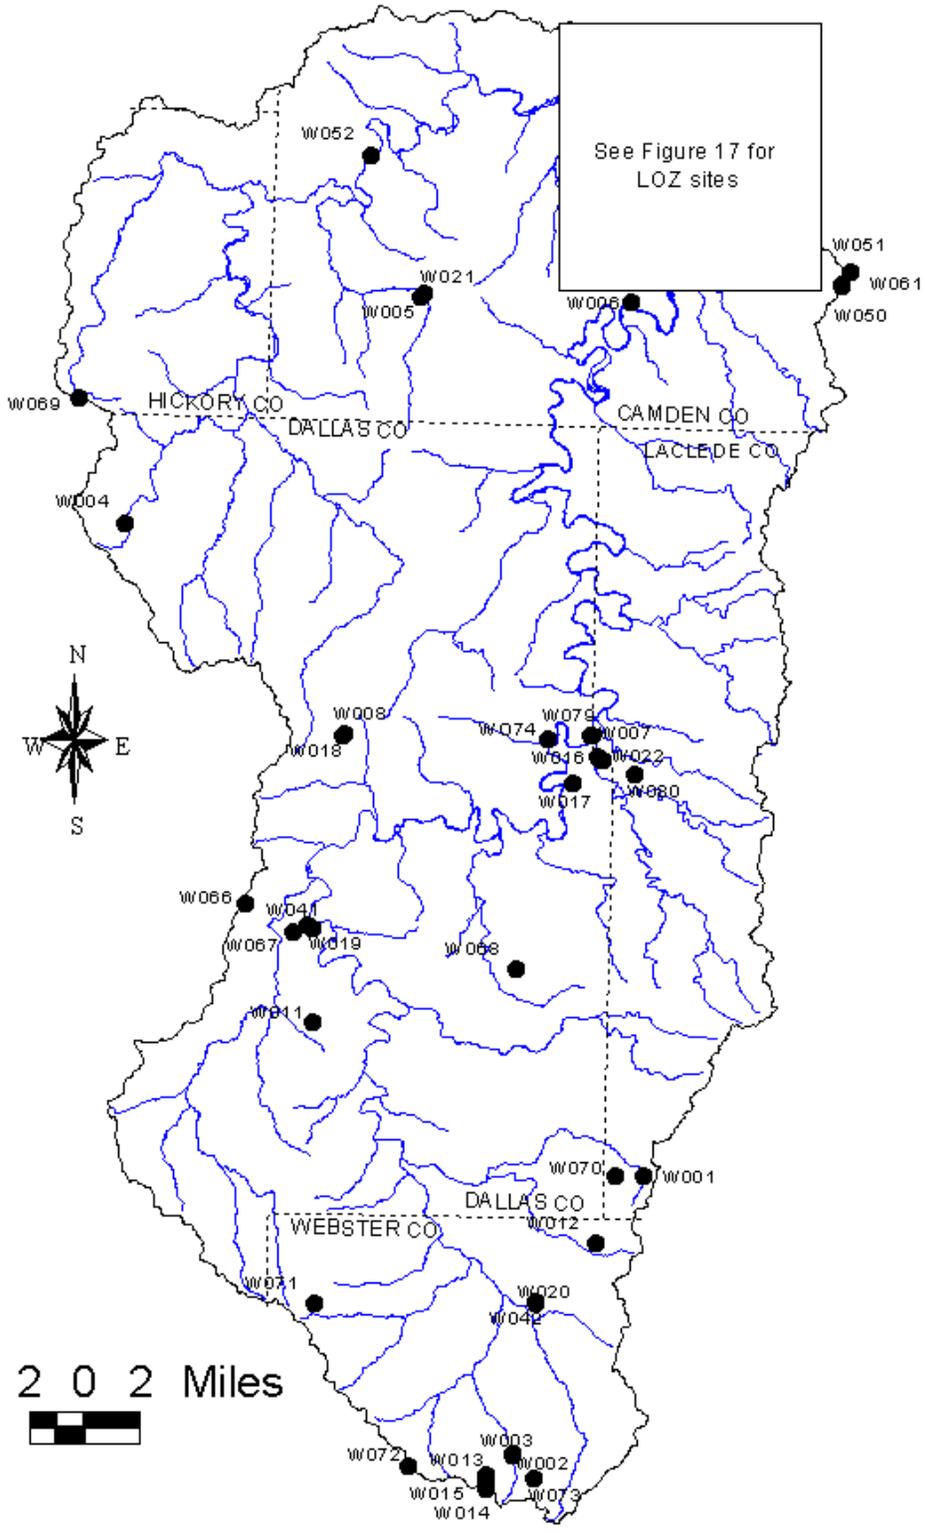
**Figure 15. NPDES wastewater discharges on streams, excluding animal waste discharges within the Niangua River Watershed.**

All wastewater discharges which are considered point sources are required to obtain National Pollution Discharge Elimination System (NPDES) permits. The MDNR issues and monitors these permits throughout the state, and the Springfield Regional Office is responsible for the Niangua Watershed. All NPDES permitted discharges as of December 13, 1995 are shown in Figure 15.

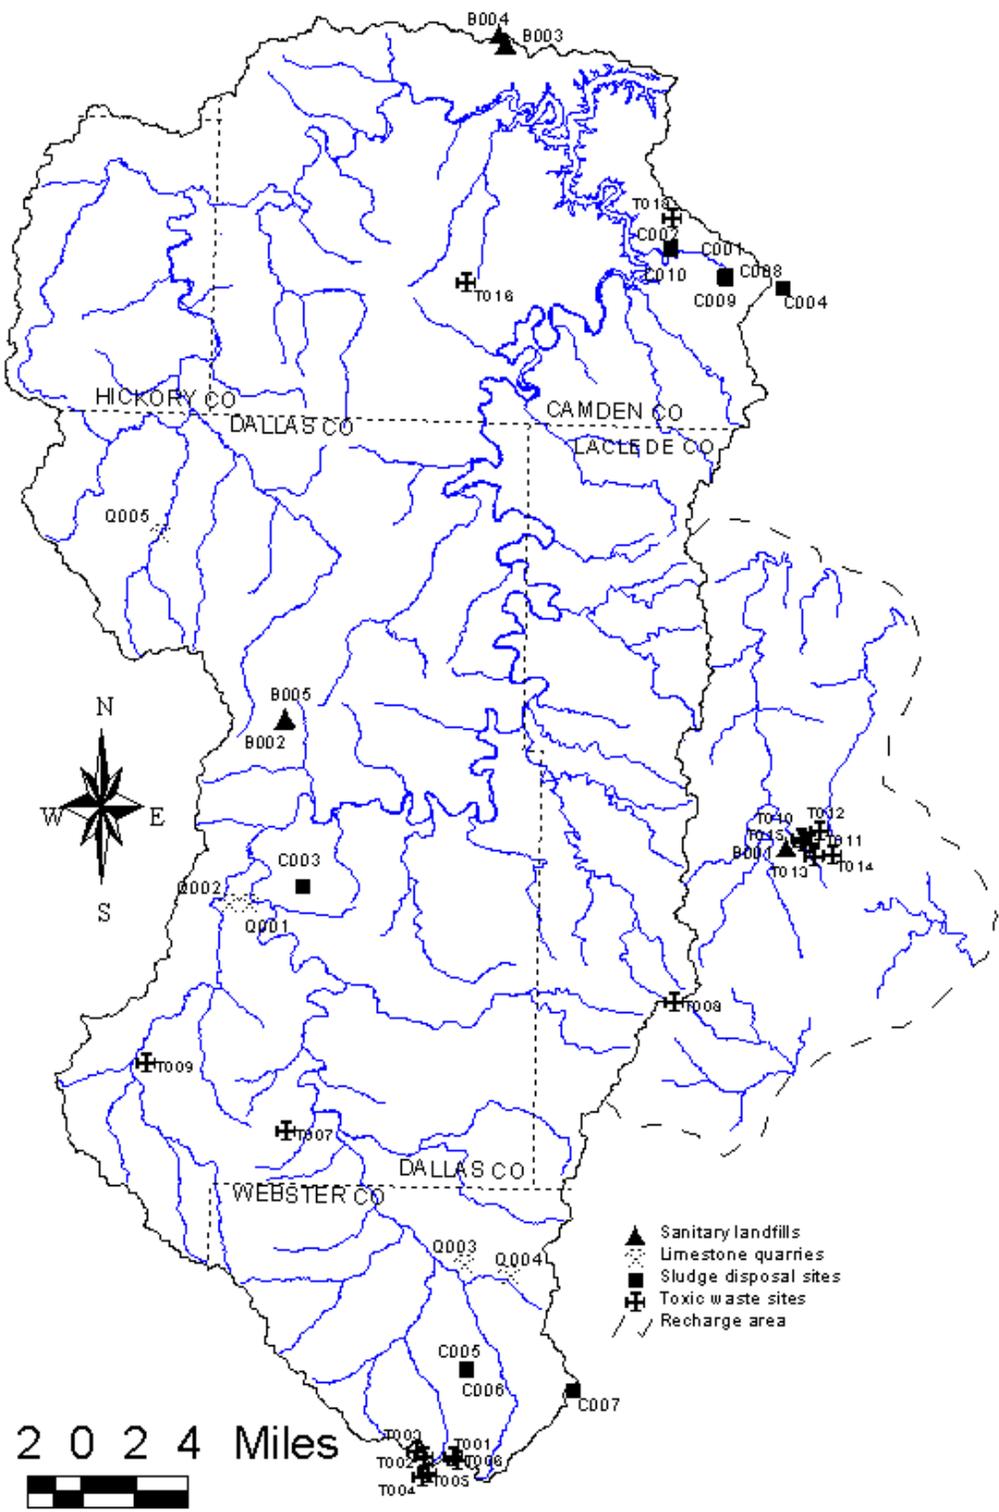
**Figure 16. Landfills, quarries, sludge disposal application sites, and toxic waste sites within the Niangua River Watershed and spring recharge area.**

- ▲ Sanitary landfills
- ◻ Limestone quarries
- Sludge disposal sites
- ⊕ Toxic waste sites
- - - Recharge area

There are nine sites within the Niangua Watershed where sludge from municipal sewage treatment plants has been applied to agricultural land (Table 19; Figure 16). These sites are all within twenty miles of the treatment plants and are permitted through the NPDES permits for each municipality. These sites are self-monitored by the municipalities who must furnish annual reports to the MDNR on the location, landowner, application dates, and amounts. Various parameters, including metal concentrations, nitrates, phosphates, and percent solids must be monitored; and individual and cumulative levels must be within limits. The MDNR has not documented any environmental problems at any of the sludge application sites in the watershed (Robert Magai (MDNR), pers. comm.).

All five municipal sanitary landfills located within the Niangua watershed have been closed (Table 20; Figure 16). The Lebanon Sanitary Landfill (B001) was active between 1977 and 1980, when all available space was exhausted. The underlying soils are poor and the site is in a karst area with a sinkhole nearby, so groundwater contamination is a concern (Jim Gross (MDNR), pers. comm.). A leachate collection system that discharges to the Lebanon STP has been installed, but on at least one occasion, leachate overflowed from a manhole to a nearby stream, a tributary to Goodwin Hollow (Jim Gross (MDNR), pers. comm.). Although this site lies outside the surface watershed of the Niangua Watershed, it and Goodwin Hollow are within a karst area that is hydrologically connected to Bennett Spring and Sweet Blue Spring. The Dallas County Landfill near Buffalo includes two sites. One (B002) was active between 1976 and 1986, and the other (B005) was active between 1980 and 1986. The landfill did not meet its closure conditions until December 1995 due to problems with surfacing leachate and inadequate vegetative cover. These problems have been corrected, but there is still concern that leachate may pass through the porous soil and

Eighteen sites with potential toxic or hazardous waste problems have been identified (Table 17; Figure 16). They are all sites regulated and monitored by the MDNR under several programs. The Leaking Underground Storage Tank Program maintains a list of known leaking, buried tanks containing substances which have known or potential water pollution problems. The Underground Storage Tank Program maintains a list of registered buried tanks that are not known to leak. Owners of these sites were required to register these tanks by August 28, 1996 to become eligible for insurance which limits their liability to \$10,000 for future pollution problems. The Toxic Release Inventory (TRI) contains detailed

Five limestone quarries have been permitted by the Land Reclamation Program (MDNR) (Table 22; Figure 16). One facility (Q001) is currently being investigated by the MDNR. The owner has a NPDES permit that limits suspended solids in its discharges and is responsible for self-monitoring them twice per year. A MDNR inspection in September 1996 revealed that sediment buildup in two detention basins could result in highly turbid discharges during storm runoff (Kevin Hess (MDNR), pers. comm.). The owner has been advised to clean out the basins.

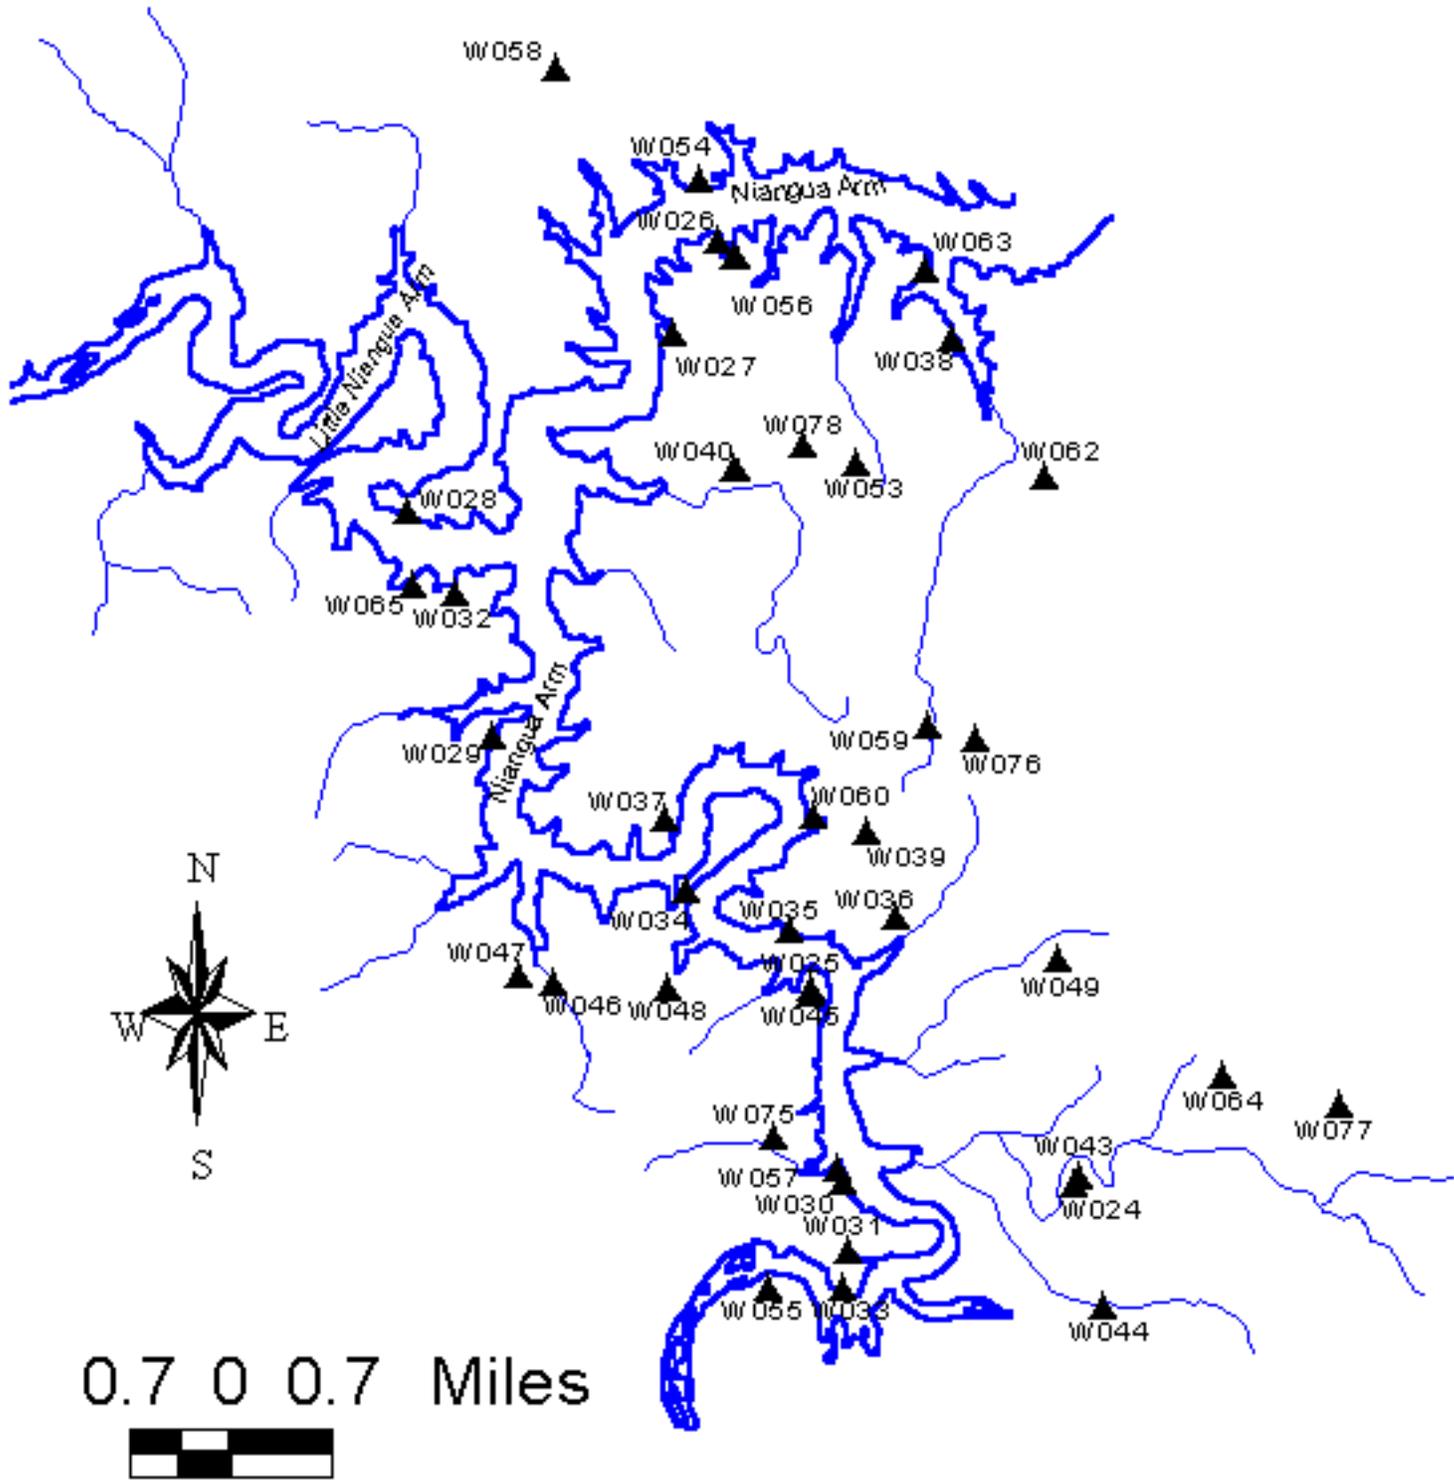
Figure 17. NPDES permitted waste water discharges on Lake of the Ozarks.

There are 48 permitted non-POTWs (non-public owned treatment works) within the watershed. Thirty-one discharge into either the Niangua Arm or the Little Niangua Arm (Figure 17). These facilities are mostly extended aeration treatment systems with chlorinated effluent and flows in the range of 1,000 to 55,000 gallons per day (GPD). They are self-monitored quarterly, semiannually, or annually depending on the flow and site conditions. The number of permits for non-POTWs releasing effluent to LOZ has increased dramatically in recent years. Occasional violations of water quality standards have been reported in highly developed coves (Mitzelfelt, 1985). Due to the neglect of proper maintenance and the infrequent monitoring of these facilities, their contribution to nutrient loading and pathogen contamination of the lake is probably considerable.

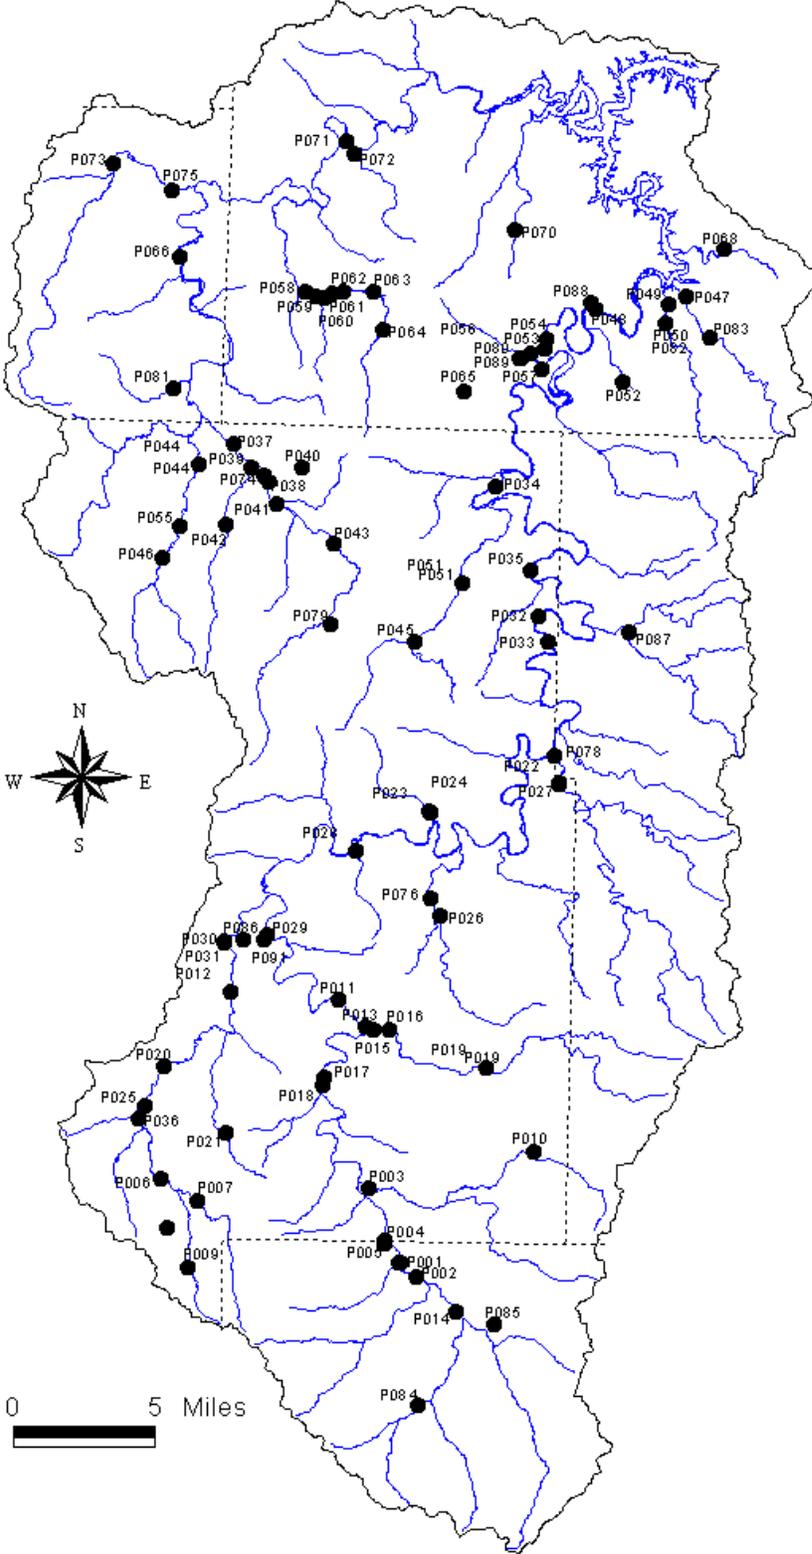
**Figure 18. USCOE and MDNR permitted instream activities and violations within the Niangua River Watershed.**

Seventy-seven known permits were issued for 404 activities within the watershed between July 1992 and June 1996 (Appendix F; Figure 18). Only COE permits are listed for most of the sites. MDNR land reclamation permits were also issued for many of these sites, but are only included if no COE permit was recorded. The vast majority of permits (51) were issued for gravel removal. Eleven permits were issued for bridge construction or repairs, and six for bank stabilization. One permit was issued for pipeline armoring. MDC Fisheries Management personnel formally reported twenty violations to the COE during the same time period. Seventeen of these were associated with sand and gravel removal, including eight unpermitted sites and eleven occasions with one or more permit violations.

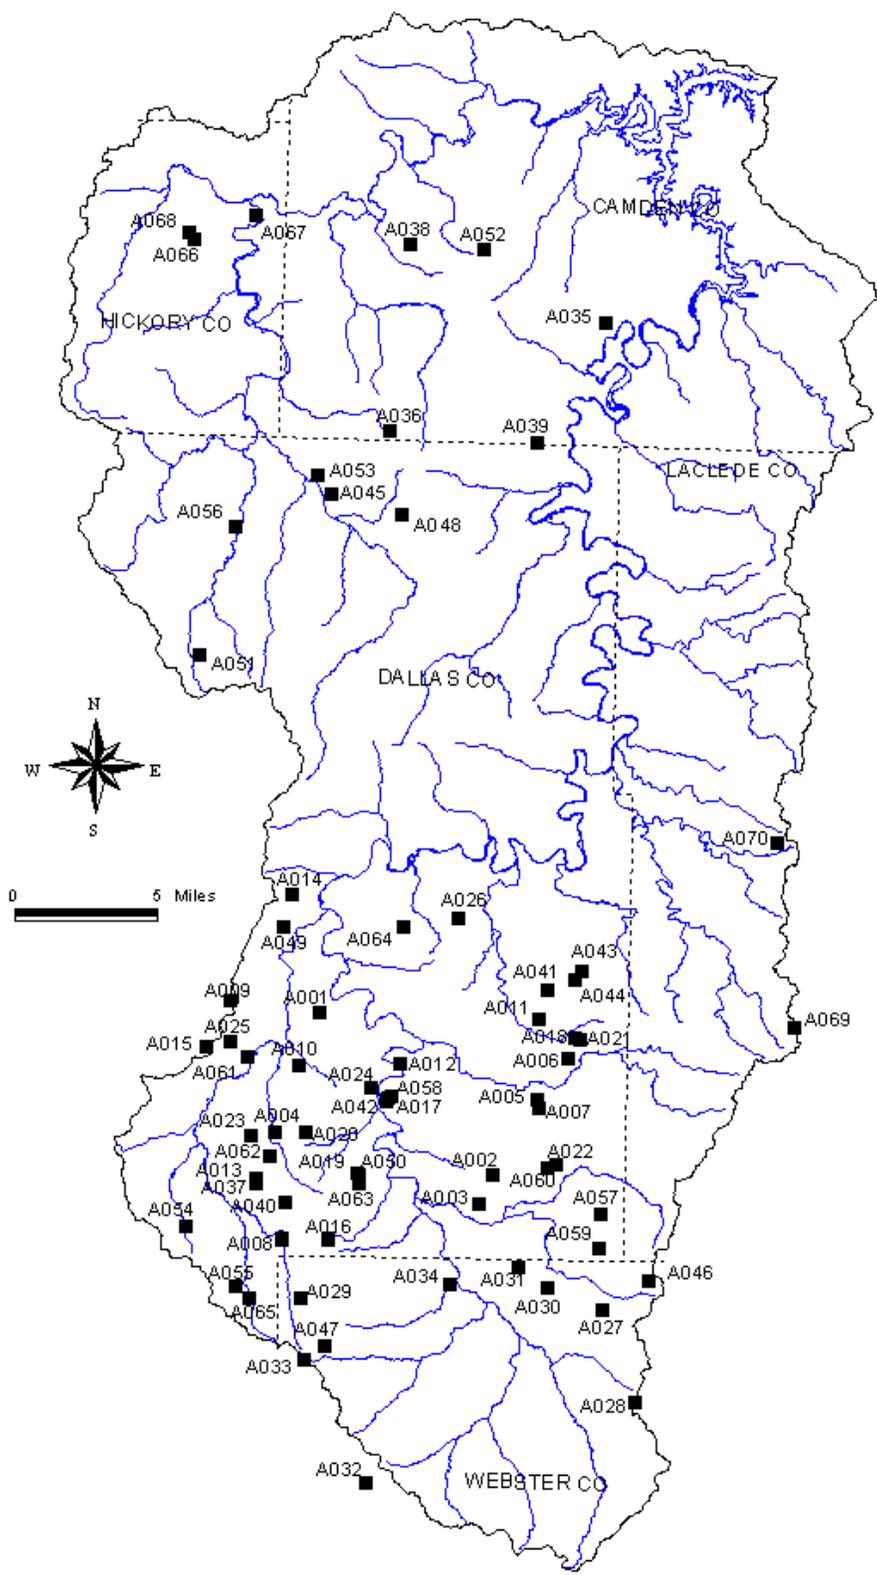
Figure 19. NPDES animal waste sites within the Niangua River Watershed.

Seventy-one animal waste point sources are currently permitted within the watershed (Figure 19). As shown in Table 23, 51 of the 71 animal waste point sources are dairies, 11 are swine operations, and four are poultry operations. The total human population equivalent (PE) of the permitted facilities, for which PE data is available, is 113,766 (Table 18). This is far greater than the estimated 1994 human population of the watershed (34,679) and only includes animals in confinement facilities which have point discharges. Facilities which do not have permits or for which PE data is not available are not included, so this is a conservative estimate. Livestock in pastures, which occur in much greater numbers in the watershed, are considered in the following section. Most of the point sources are dairy farms with less than 300 animal units, and many have received UNAWP assistance for installing waste treatment systems. The University Extension Office in Dallas County estimates that 28 percent of the total manure

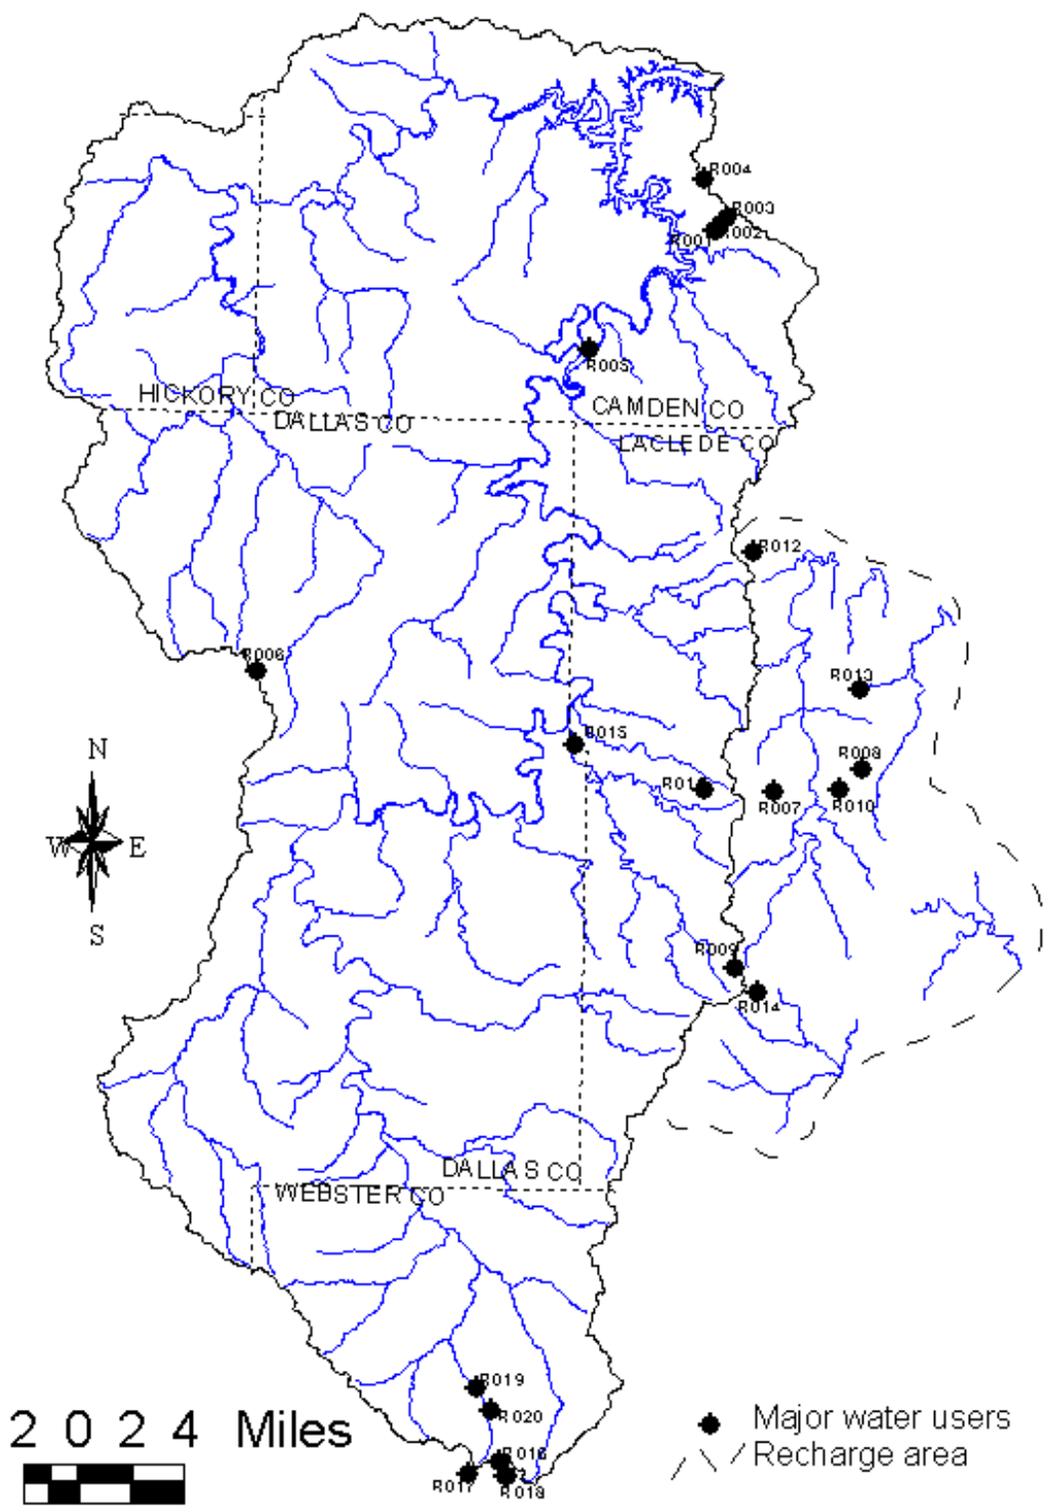
**Figure 20. Major water users listed by the MDNR within the Niangua River Watershed and spring recharge area.**

The known major groundwater and surface water users in the watershed and within spring recharge areas are shown in Table 21 and Figure 20. There are no public water supply withdrawals from surface waters in the watershed. There are only four surface water users on record. The first, Sho-Me Power Corporation (R005) operates the Tunnel Dam Project for hydroelectric power generation. All of the water used for power generation is returned to the river 6.5 miles downstream from the dam. Since most of the flow of the NR during normal flows is used, this user can have a dramatic effect on water quality and aquatic life especially in the bypass loop. The utility must allow minimum flows in the bypass loop to maintain aquatic life (see Hydrology Section).
